TECHNICAL REPORT REMR-CO-3

CASE HISTORIES OF CORPS BREAKWATER
AND JETTY STRUCTURES

Report 7

NEW ENGLAND DIVISION

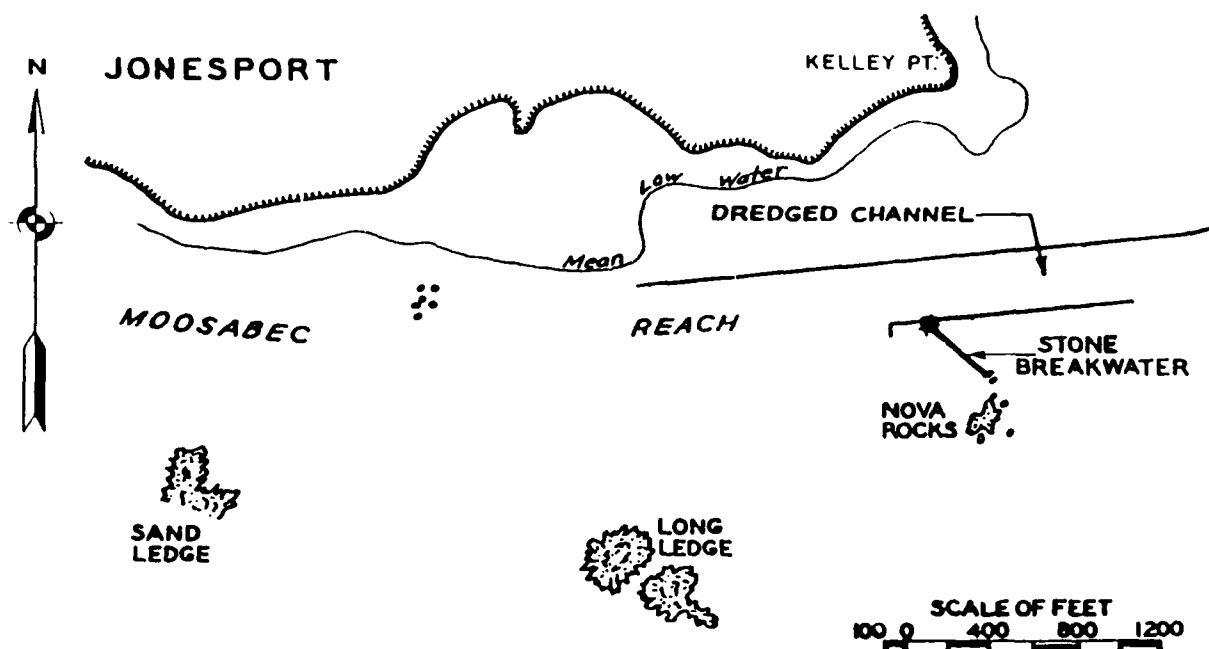
Figure 4. Plan view of breakwater at Moosabec Bar, Maine

Date(s)	Construction and Rehabilitation History
1891 1892	As part of channel improvements, a 400-ft-long rubble-mound breakwater was constructed (Figure 4).
1962- 1977	Inspections of the breakwater indicated several small breaks along the top, but its overall condition was considered fair to good.
1986	The structure has no known repair history.

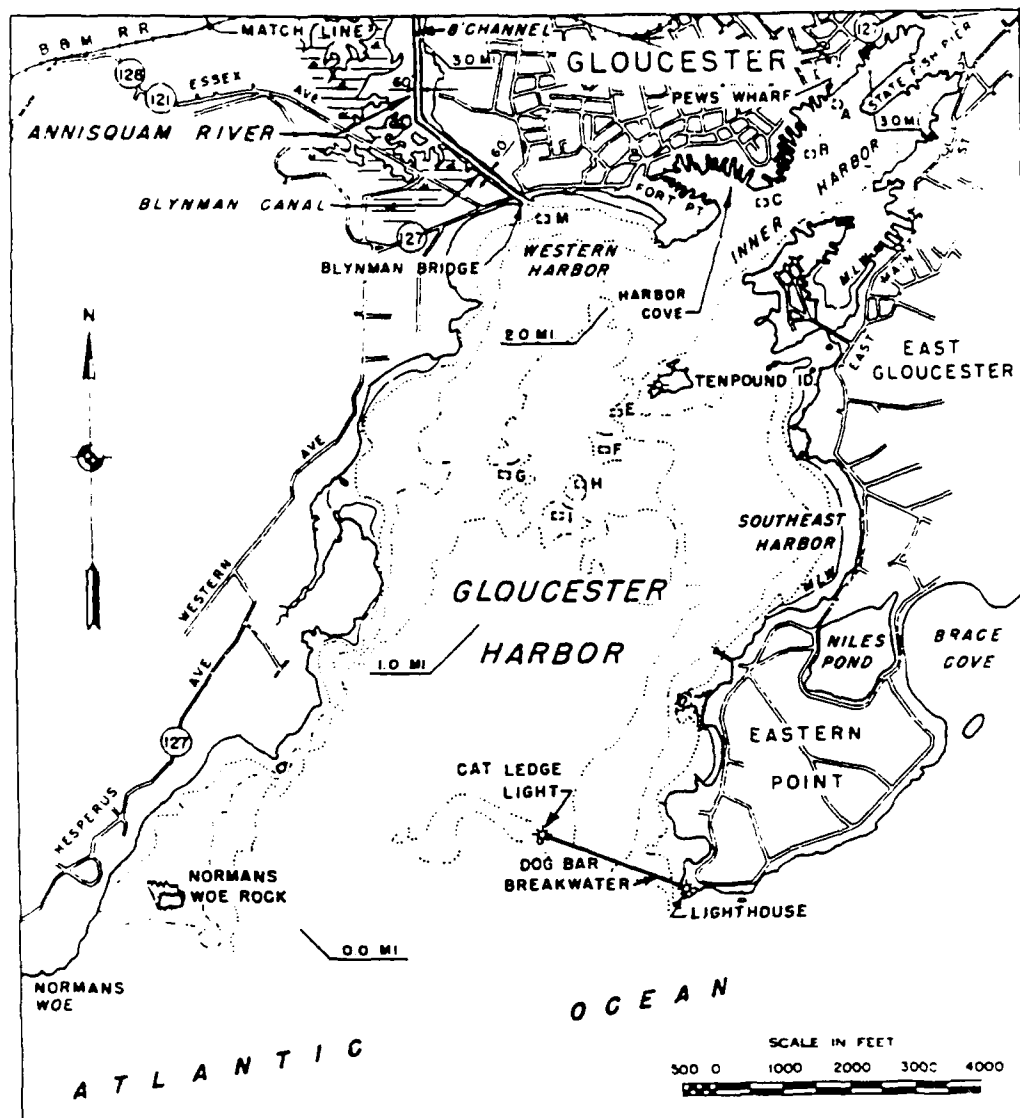
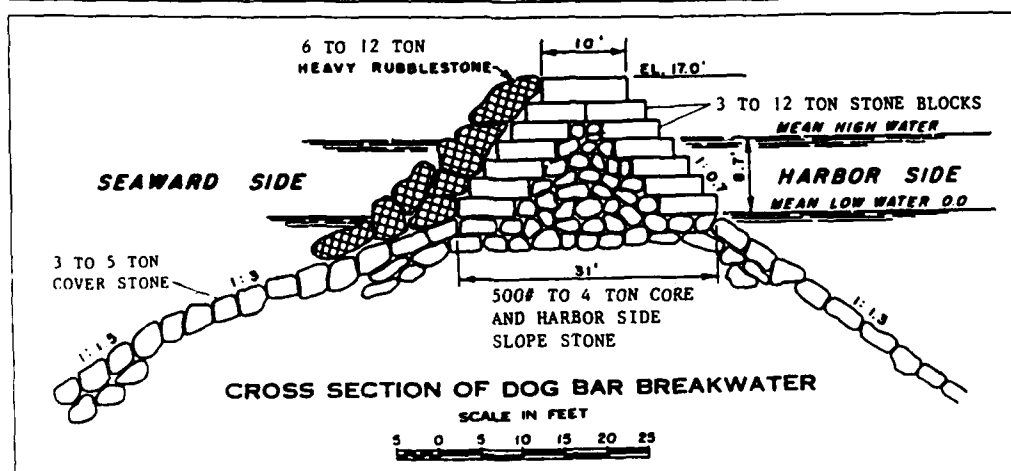
Figure 23. Plan view and typical section of Dog Bar breakwater at Gloucester Harbor, Mass.

1967- 1978	Breakwater inspections, taken over this period, showed a gradual deterioration of the sea-side armor stone at several locations. Most of the damage was on the outer half of the breakwater.

1931- 1940	Minor repairs were made to the superstructure in 1931, 1933-34, 1935, 1939, and 1940. The work (approximate totals in parentheses) included resetting (2,000 tons) and replacing (1,000 tons) stone blocks, placing rubble stone (7,000 tons) on the seaward face (Figure 23, inset), and placing iron pins (700) on the harbor side stone blocks to act as buttressing for the upper courses of stone. The total repair costs were \$35,700.
1962	A breakwater inspection showed the stone block superstructure was in good condition with only localized areas needing repair. The sea-side armor stone, placed during 1931-40, was in poor condition with several large cavities and a general subsidence along the entire breakwater length.
1965- 1966	Repairs were made to the breakwater superstructure, and 10,920 tons of 6- to 12-ton armor stone were placed on the sea side between 0+00 (landward end) and 21+85. Displaced stone blocks were reset from 1+14 to 1+72 and 9+96 to 10+22. Total cost of the repairs was \$96,400.

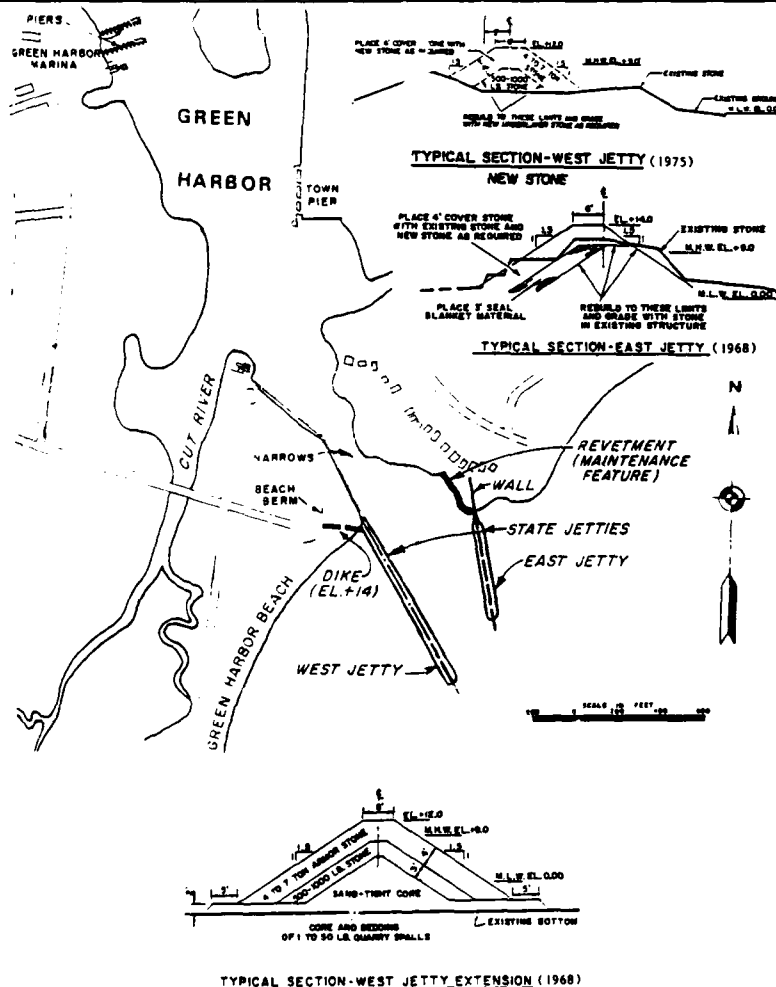
Figure 25. Plan view and cross sections of jetties at Green Harbor, Mass.

Date(s)	Construction and Rehabilitation History
1972-1974 (cont.)	worst areas as low as +4 ft mlw. It was estimated that 1,000 and 500 tons of new and salvageable stone, respectively, were needed to repair the jetty.
1975	The seaward 525-ft section of the west jetty was repaired to the 1968-69 design cross section using 4- to 7-ton cover stone and 500- to 1,000-lb underlayer stone as needed (Figure 25, inset). The repairs were made for a total cost of \$40,000.
1977	An inspection indicated that the east jetty was in good condition but that the west jetty needed some armor stone reset.
1986	Yearly inspections indicate that the jetties are in good condition. For the purpose of this report, the lengths of the east and west jetties are considered to be 645 and 850 ft long, respectively (the 1968-69 improvements plus approximately 150 ft of concrete wall landward of the east jetty repair section).

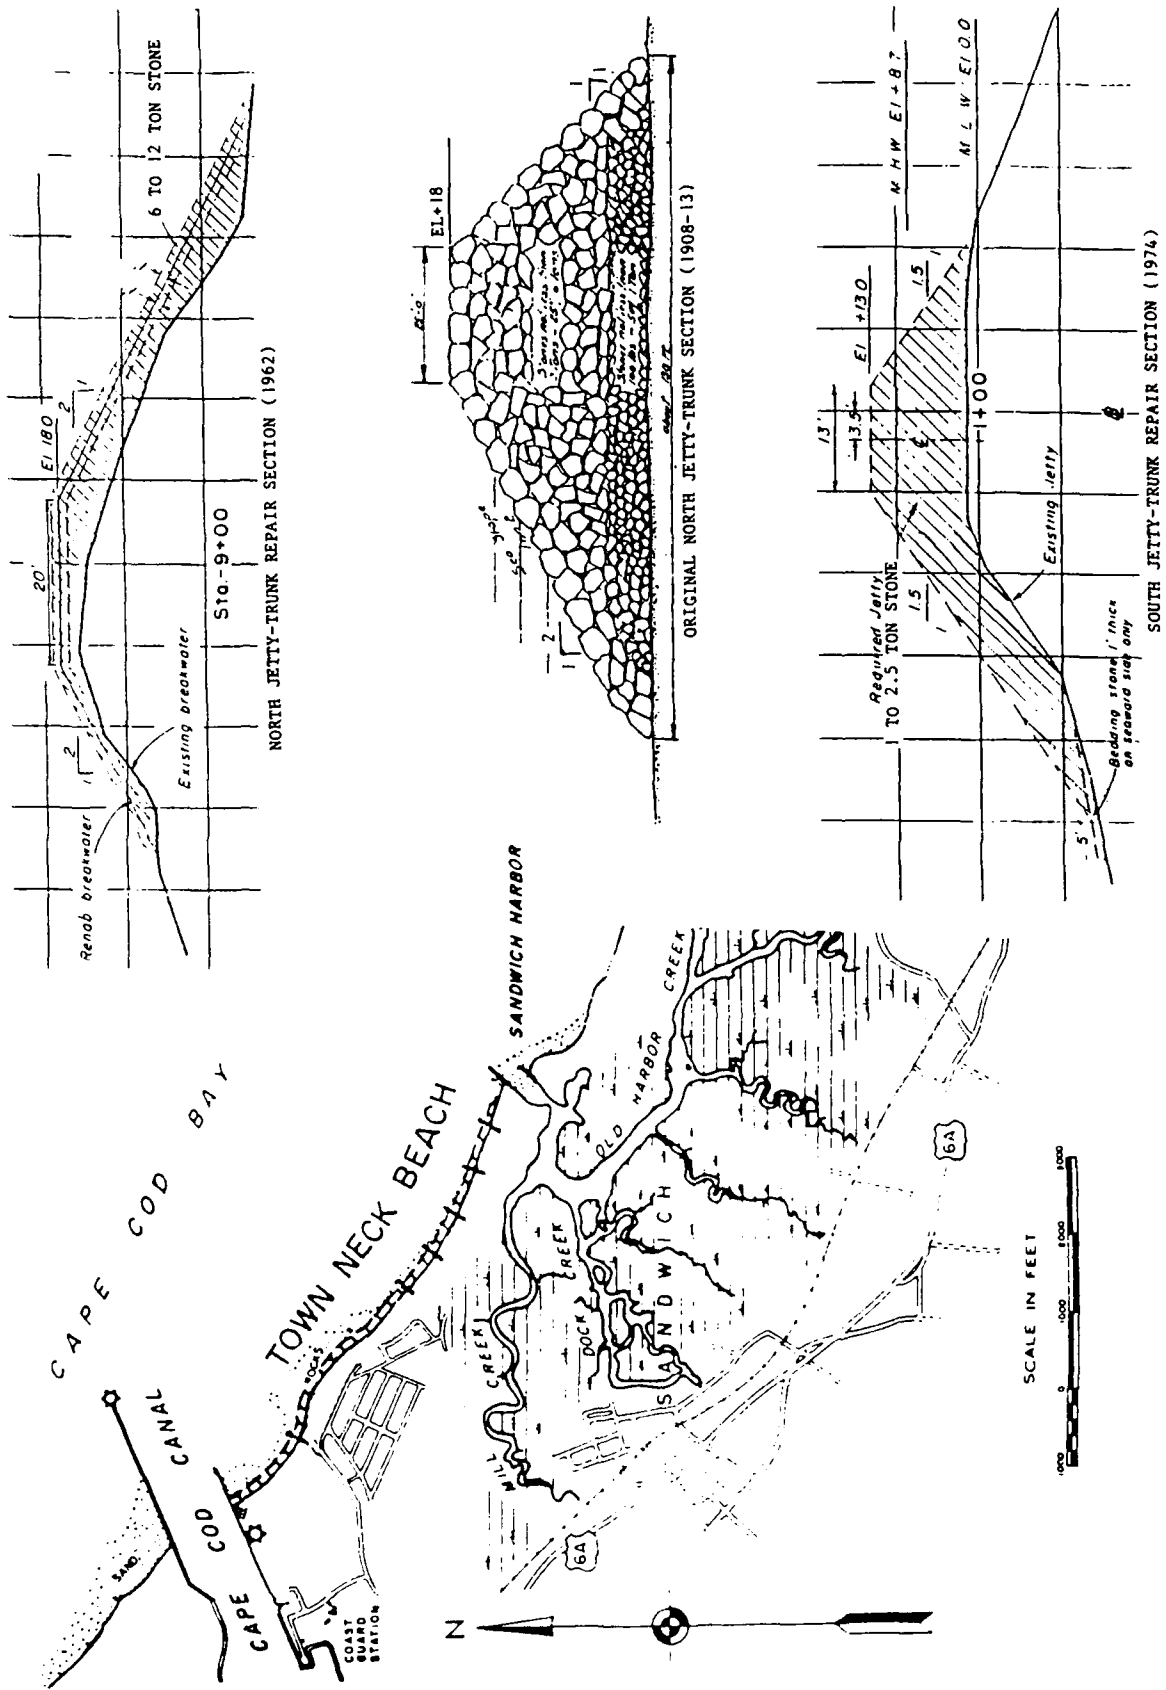
Figure 27. Plan view and typical sections of jetties at Cape Cod Canal, Mass.

1977	The jetties were visually inspected. The south jetty was found to be in good condition, while the north jetty needed repairs throughout its entire length.
1986	Recent yearly visual inspections indicated the jetties were in good condition.

1962-	The seaward 925 ft of the north jetty was rebuilt to +18 ft mlw. Stone 1963 placed on the structure weighed a minimum of 6 tons, except on the 125-ft-long head section, where the minimum size was 12 tons. The head section had a 25-ft crown width and a transition in side slopes from 1V:2H to 1V:3H in the seaward direction. A 20-ft crown width and 1V:2H side slopes were specified on the jetty trunk section. Prior to the repairs, typical crown elevations were from +14 to +18 ft mlw on the trunk section and from +7 to +18 ft mlw on the head section. The contract price for placing an estimated 20,000 tons of stone was \$260,000.
1967- 1974	Inspection reports indicate the north jetty was in good condition, while the south jetty was in poor condition with numerous voids and displaced slope stone along its entire length.
1974	The south jetty was rebuilt to +13 ft mlw. The rebuilt section was 690 ft long and terminated at the jetty's seaward end. Side slopes were 1V:1.5H. A 13-ft crown width and 5- to 7-ton stone were specified on the seaward 200 ft. The remaining section required a 10-ft crown width and 1- to 2.5-ton stone. A 1-ft-thick layer of bedding stone, 0 to 50 lb in size, was placed along the outermost 450 ft of the jetty's seaside toe. Prior to the repairs, crown elevations were typically from +3 to +8 ft mlw. The contract price for placing an estimated 15,500 tons of stone was \$224,800.

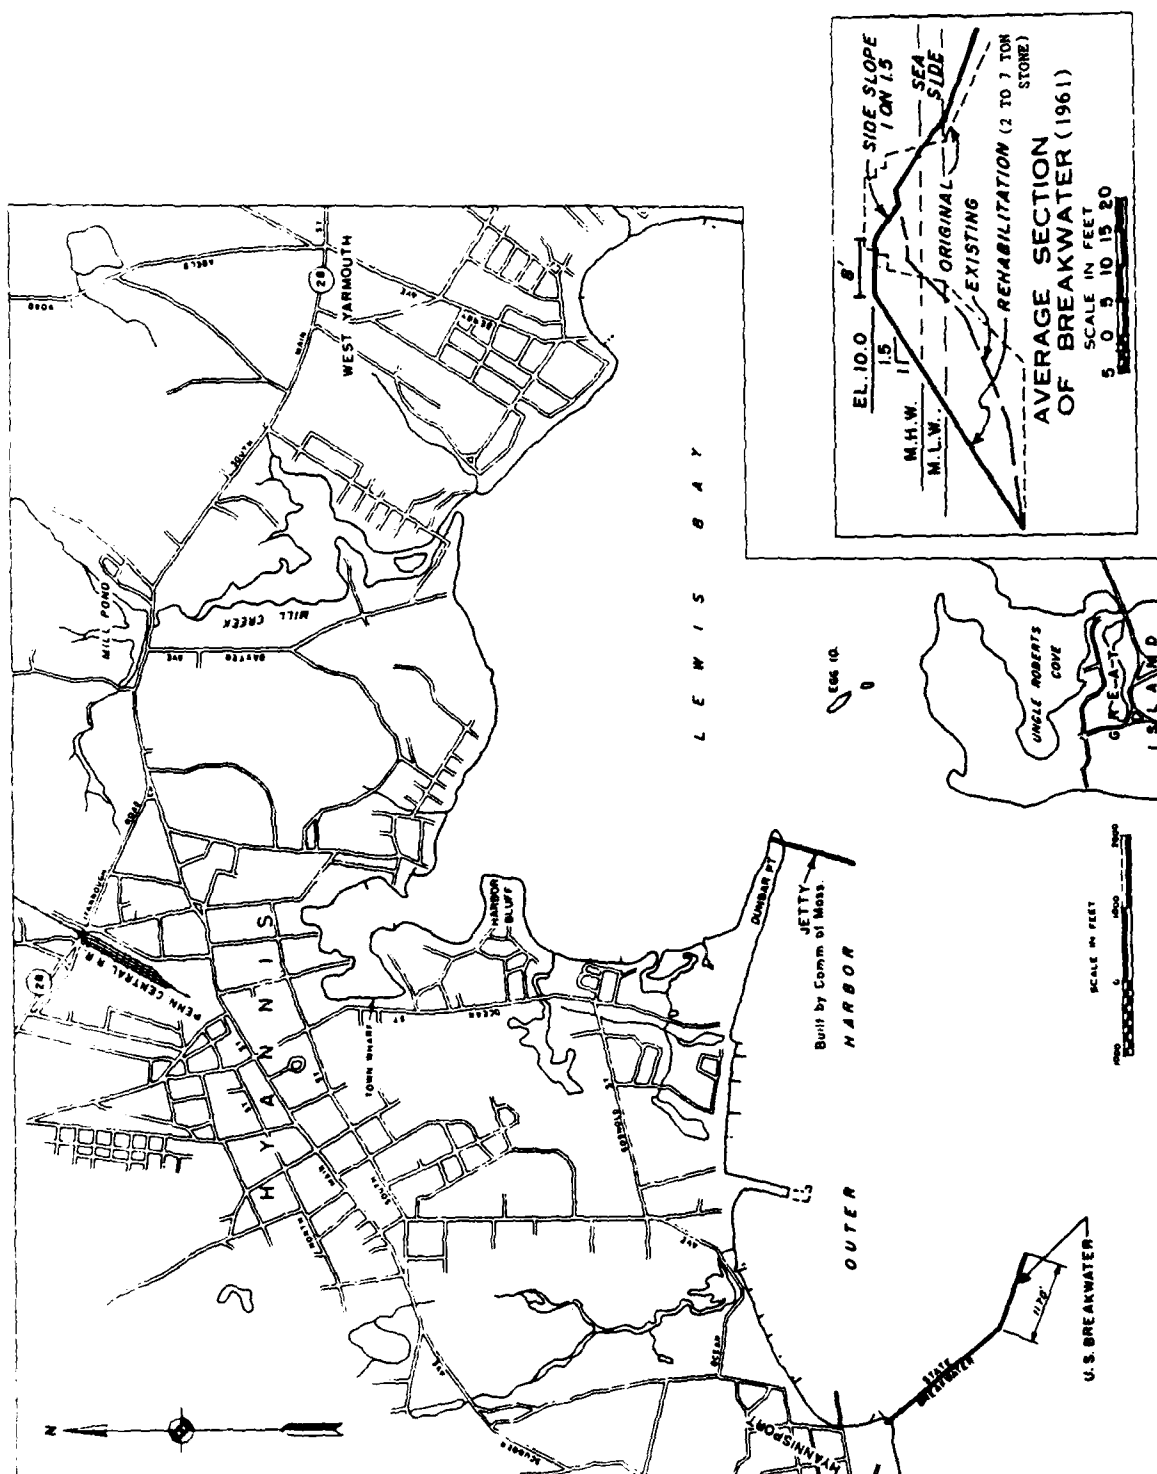
Figure 32. Location map of breakwater at Hyannis Harbor, Mass.

Date(s)	Construction and Rehabilitation History
1827- 1936	The breakwater (Figure 32, plan view) was constructed between 1827 and 1837 and rebuilt between 1870 and 1882. The inner leg of the breakwater, about 2,250 ft long, was built by the State of Massachusetts. The 1,170-ft-long outer leg of the breakwater was built and maintained by the Federal government. The rebuilt cross-section had a 10-ft crown width at +10 ft mlw and may have been of cut stone construction since the side slopes were nearly vertical. Minor repairs were made in 1936.
1950	The outer 1,170-ft-long leg of the breakwater and adjacent 10 ft of state breakwater were repaired with 1- to 6-ton stone. The repair geometry consisted of a 10-ft crown width at +10 ft mlw and 1V:1H side slopes. A total of 3,224 tons of stone was placed for a cost of \$29,200. Prior to the repairs, existing crown elevations varied from +5 to +10 ft mlw. The State portion of the breakwater was considered to be in poor condition.

1961	The outer leg of the breakwater was repaired from 0+00 to 7+80 and 10+75 to 11+15 (breakwater bend at 0+00, seaward end at 11+70). The repair section consisted of an 8-ft crown width at +10 ft mlw, 1V:1.5 side slopes, and 2- to 7-ton armor stone. Before the repairs, crown elevations were from +5 to +10 ft mlw. The repair costs were \$129,800 using a total of 13,588 tons of stone.
1966- 1974	Inspections indicated the Federal portion of the breakwater was in fair condition.
1982- 1986	Yearly visual inspections indicated the breakwater was in good condition.

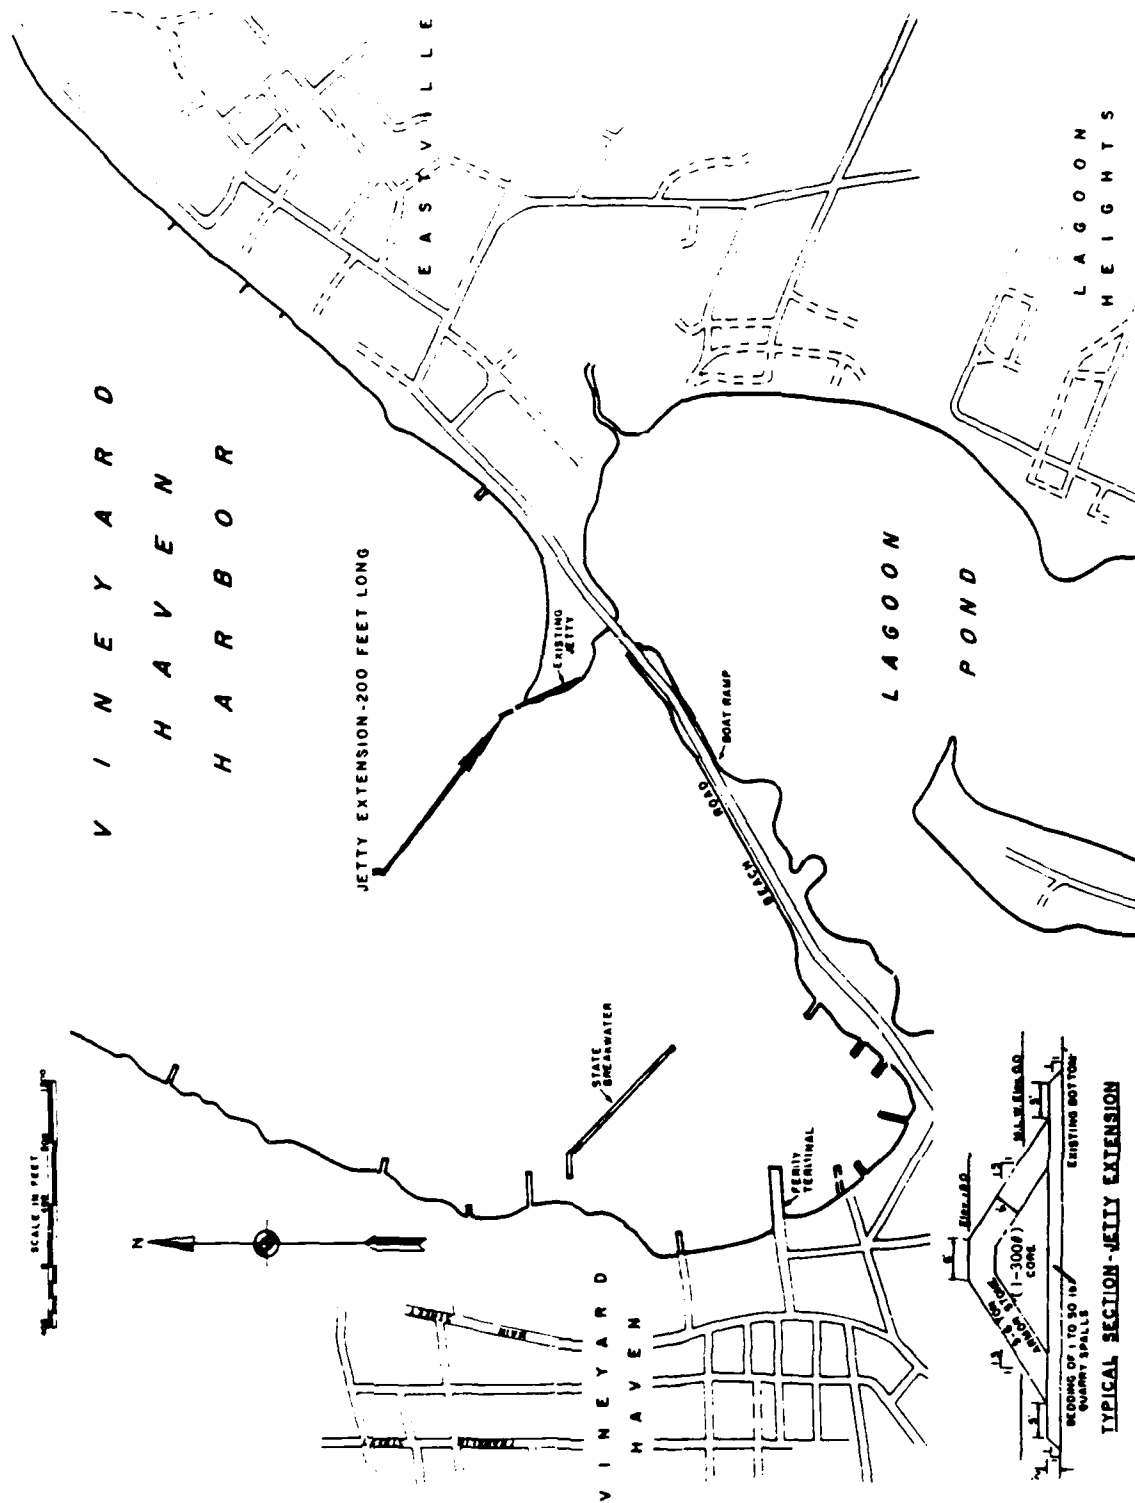
Figure 33. Plan view of Lagoon Pond Jetty, Martha's Vineyard, Mass.

1974	The jetty and extension were considered to be in excellent condition during a visual inspection.
1982- 1986	Yearly visual inspections of the jetty revealed that it was in good condition.

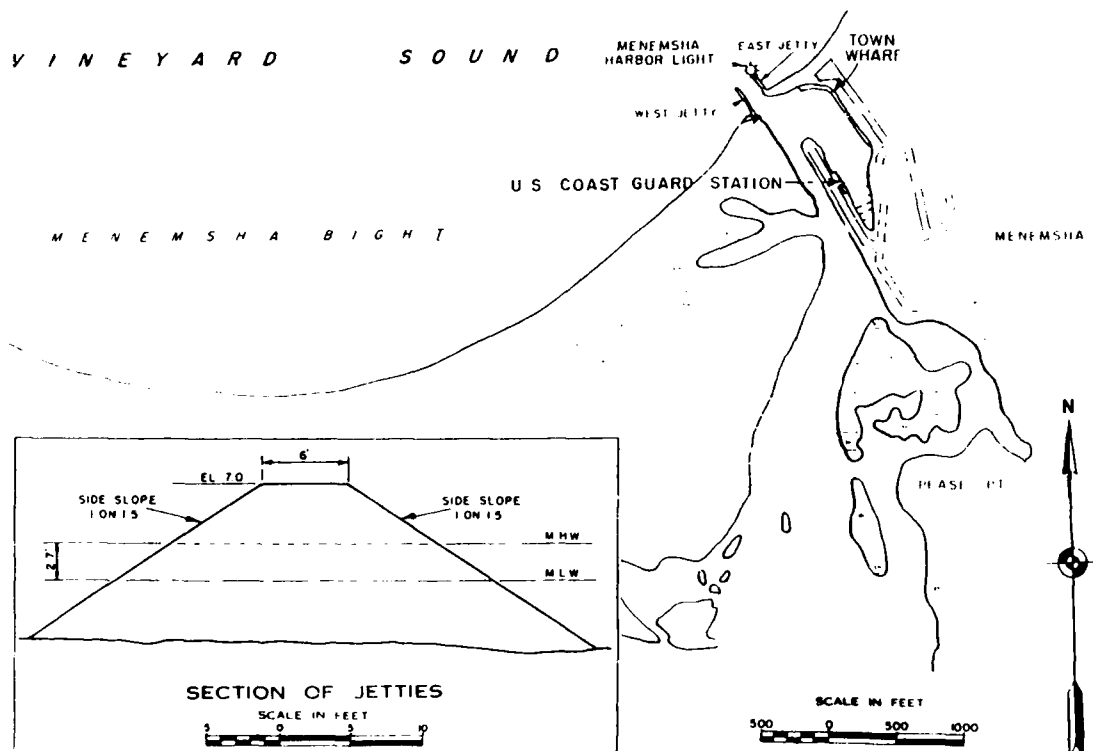
Figure 34. Plan view and typical section of Menemsha Creek jetties, Martha's Vineyard, Mass.

Date(s)	Construction and Rehabilitation History
1945	The east and west jetties, approximately 250 and 435 ft long, respectively, were constructed by non-Federal interests prior to 1945 (Figure 34). The project, adopted by the government in 1945, included maintenance of the riprap jetties.
1969	The west jetty was rebuilt by placing approximately 2,100 tons of cover stone and 900 tons of seal stone. The repairs were made over a distance of 435 ft at a contract cost of \$67,500. The design section consisted of a +7 ft mlw crown elevation, a 6-ft crown width, and 1V:1.5H side slopes.
1981	The east jetty was rebuilt with 20-to 400-lb core stone and 1- to 3-ton cover stone. The design section had 1V:1.5H side slopes and a 6-ft crown width at +7 ft mlw. The contract price for placing an estimated 2,750 tons of stone was \$91,600.
1982-1987	Annual visual inspections of the jetties indicated they were in good condition.

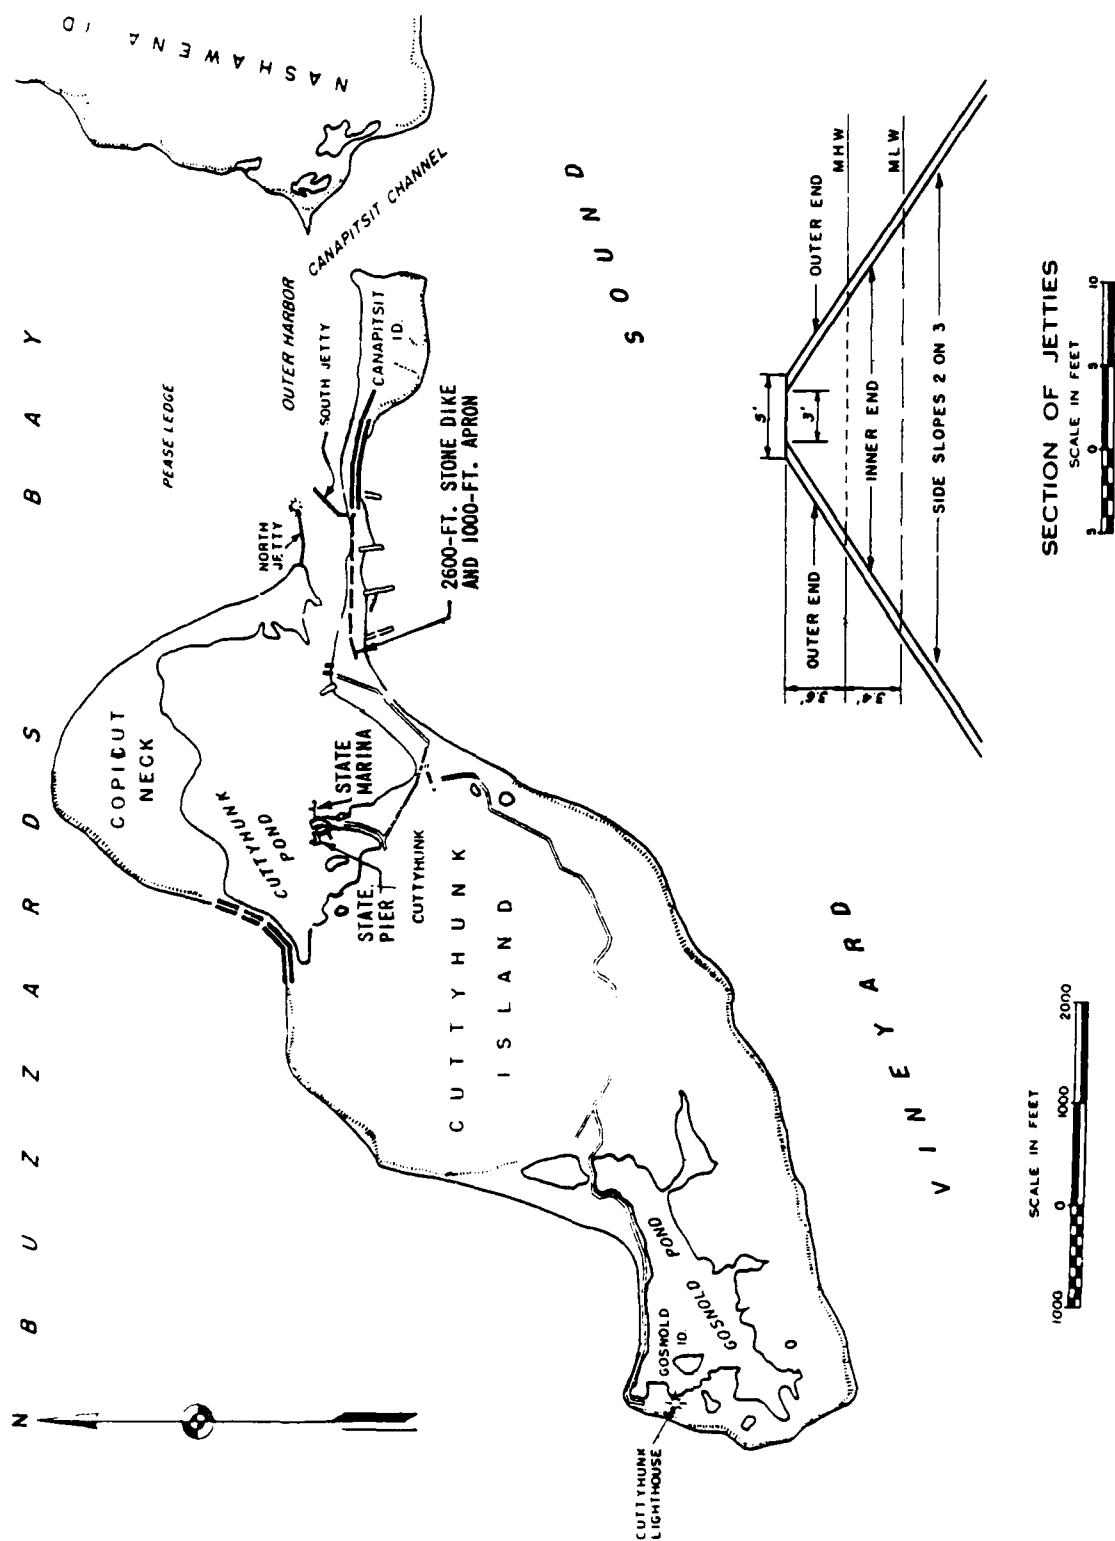
Figure 35. Jetties at Cuttyhunk Harbor, Mass.

1984- 1986	Annual visual inspections indicated the jetties were in good condition.

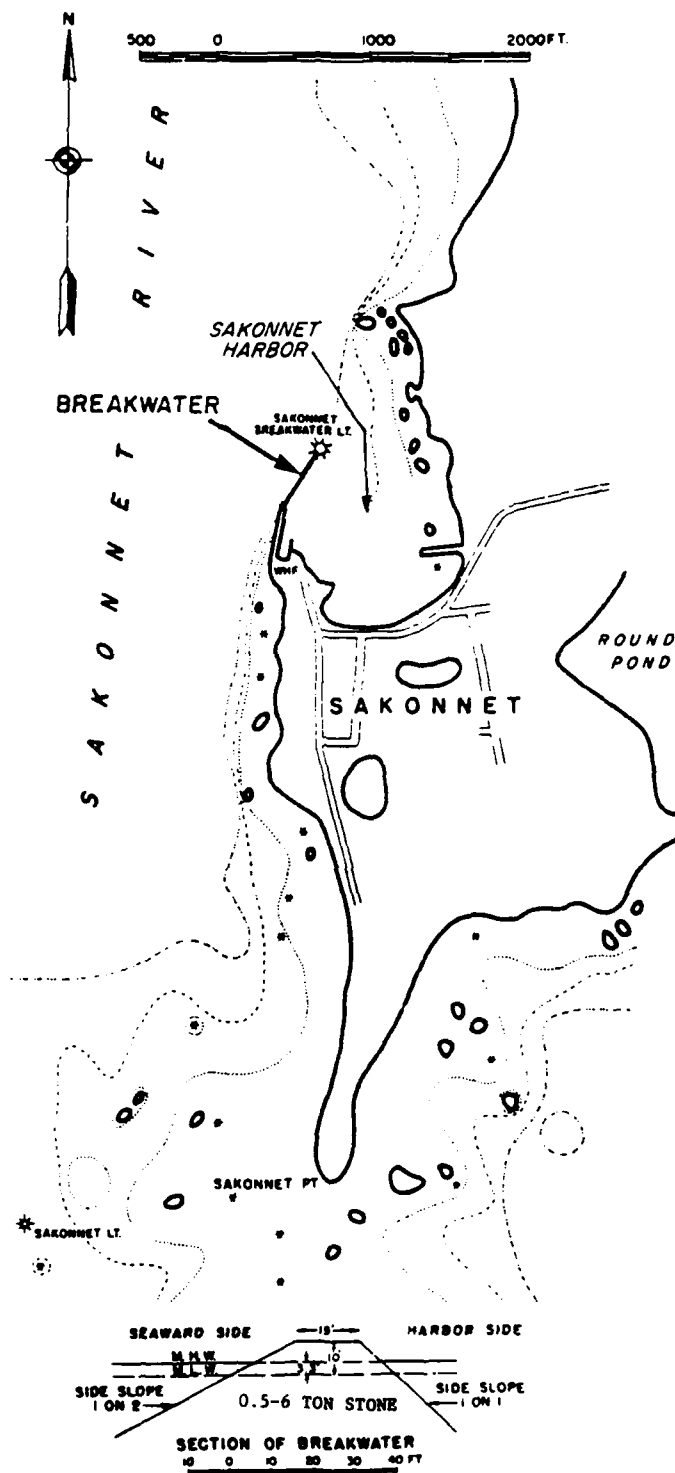
Figure 36. Plan view and typical section of breakwater at Sakonnet Harbor, R.I.

1960	A June topographic survey shows cross sections for the entire breakwater approximately 2 ft above the design cross section used in 1957. The reason for the apparent change in datum could not be found (for present report purposes).
1961	Repairs were made on three sections totaling 86 lin ft, including a 25-ft section at the seaward end and 9- and 52-ft sections located approximately 140 and 430 ft from the seaward end, respectively. The repairs were made with 0.25- to 5-ton stone placed to an elevation of +10 ft mlw, a 15-ft crown width, and slopes of 1V:2H and 1V:1H on the sea and harbor sides, respectively. Except for the outermost 15 ft of repairs, which appears to have subsided prior to June 1960, the repair areas were apparently damaged by storm waves sometime between the June 1960 survey and a visual inspection in February. The damaged areas had typically subsided from 3 to 5 ft. The contract cost for placing an estimated 1,200 tons of stone was \$14,400.

1971- 1972	Minor harbor-side slope repairs were made near the landward end of the breakwater. The new riprap was placed for a total cost of \$1400. The overall condition of the breakwater was good, except for some seaside slope stone slippage.

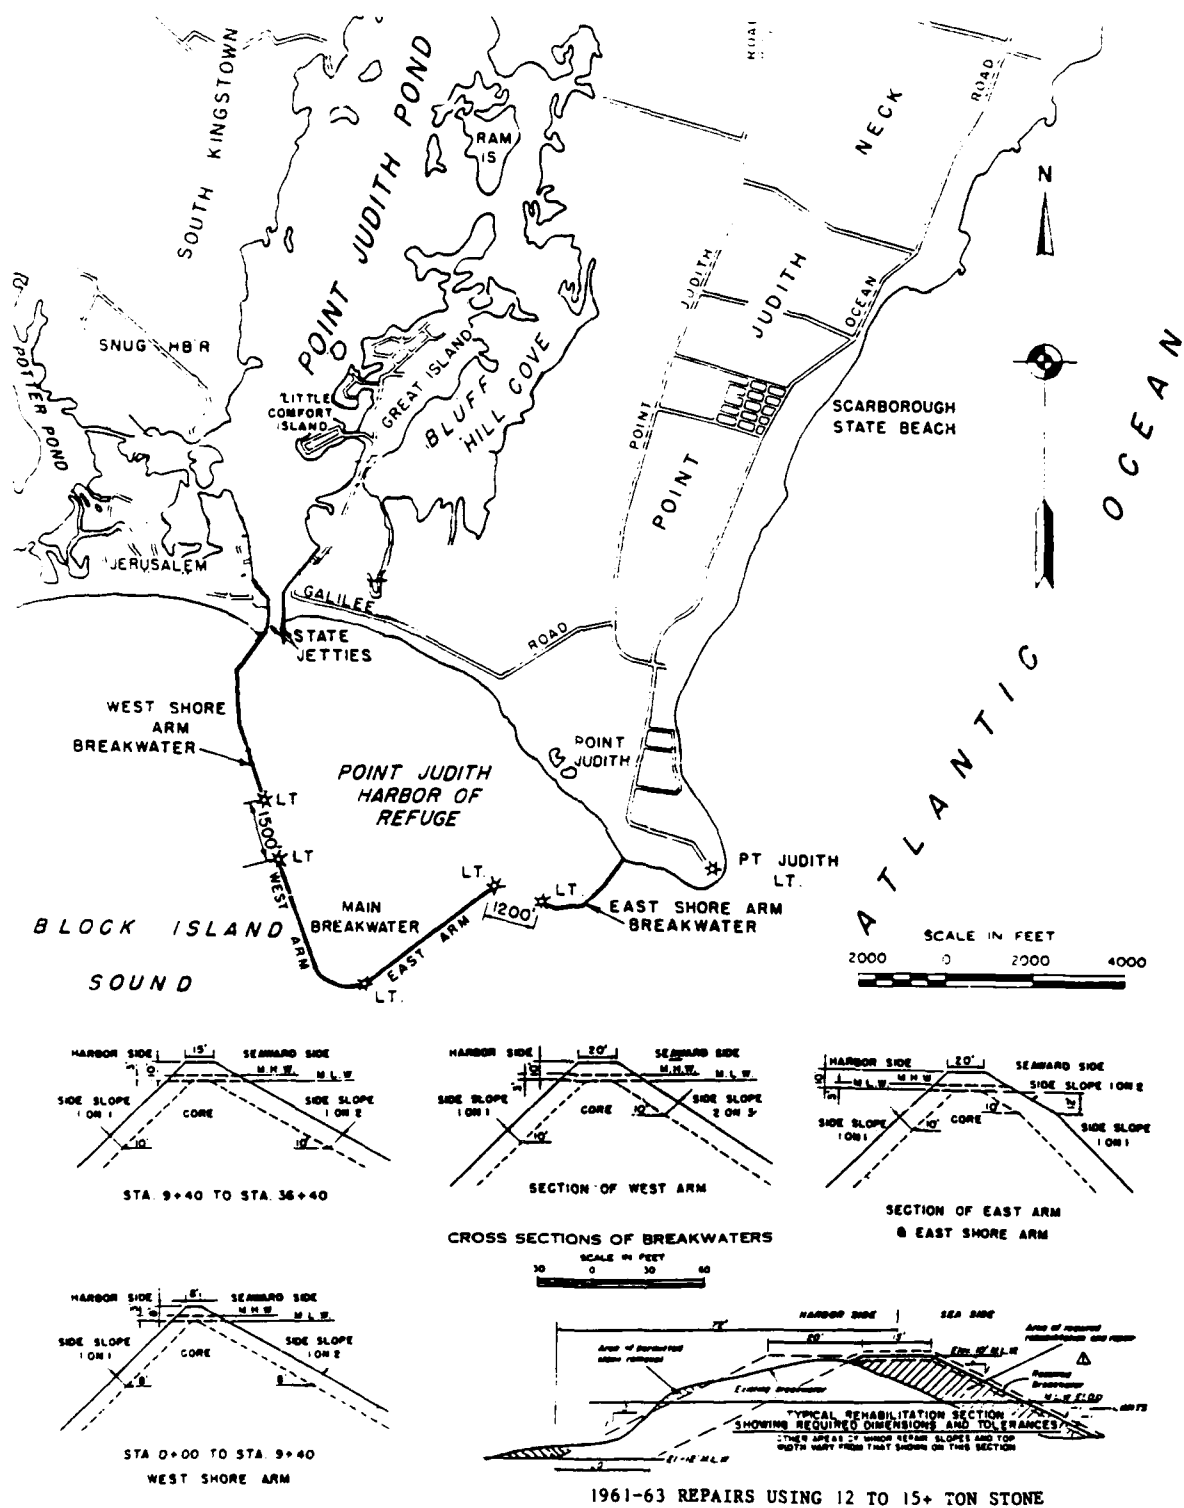
Figure 40. Plan view and typical sections of breakwaters at Point Judith Harbor of Refuge, R.I.

1961- 1963	<p>The breakwaters were rehabilitated (Figure 40, inset) using 119,000 tons of stone for a total cost of \$1,771,900. The east shore arm was repaired from 9+50 to the reconstructed seaward end at 20+00. The main breakwater was repaired from the seaward end of the west arm at 0+00 to 4+00, at 10+50, and from 31+00 to the seaward end of the east arm at 69+25. Eleven areas, the largest covering 60 lin ft, of the west shore arm were repaired between 12+80 and the seaward end at 36+10. Stone placed on the structures weighed 12 to 15 tons, except for several sections along the east arm where a 15-ton minimum was specified. The repair areas required a +10 ft mlw crown elevation. The east and east shore arm repairs required a 15-ft crown width and 1V:2H side slopes. The west and west shore arm repairs specified 20- and 15-ft crown widths, respectively, with slopes of 1V:1.5H and 1V:1H on their sea and harbor sides, respectively. Prior to rehabilitation, crown elevations within the repair areas were typically from +4 to +9 ft mlw on the east and west arms, 0 to +8 ft mlw on the east shore arm, and +7 to +10 on the west shore arm. Crown elevations outside the repair areas were typically within 2 ft of the +8 and +10 ft mlw design elevations. Overall, the east arm and outer half of the east shore arm were the most deteriorated sections of the breakwaters prior to rehabilitation.</p>

1964- 1978	<p>Visual inspections show a gradual deterioration of the main and east shore arm breakwaters. The west shore arm had some displaced stone but was otherwise considered to be in good condition. By 1978, the</p>

Date(s)	Construction and Rehabilitation History
1964- 1978 (cont.)	main and east shore arm breakwaters were in poor to very poor condition with numerous deficiencies in cross section, and there were significant amounts of displaced stone on the harbor side of the structures at several locations.
1983- 1984	The east shore arm breakwater was repaired, and the main breakwater repairs were started but were not completed due to contractual difficulties. The east shore arm repairs were made using 12- to 15-ton stone and resetting existing stone. The majority of the repairs were located on the seaward half of the breakwater from 10+50 to 20+30. The breakwater was rebuilt to a +10 ft mhw crown elevation, a 20-ft crown width, and slopes of 1V:2H and 1V:1H on the sea side and harbor side, respectively. The cost of repairs was \$702,500 for 20,275 tons of new stone and \$81,870 for resetting existing stone. The incomplete main breakwater repairs were identical to the east shore arm repairs in stone weight and cross section geometry, except for the side slopes which were 1V:1.5H from 0+00 to 20+34 and 1V:2H from 20+34 to 67+25. The contract, awarded in the amount of \$2,275,000, called for placing 57,600 tons of stone and resetting existing stone.

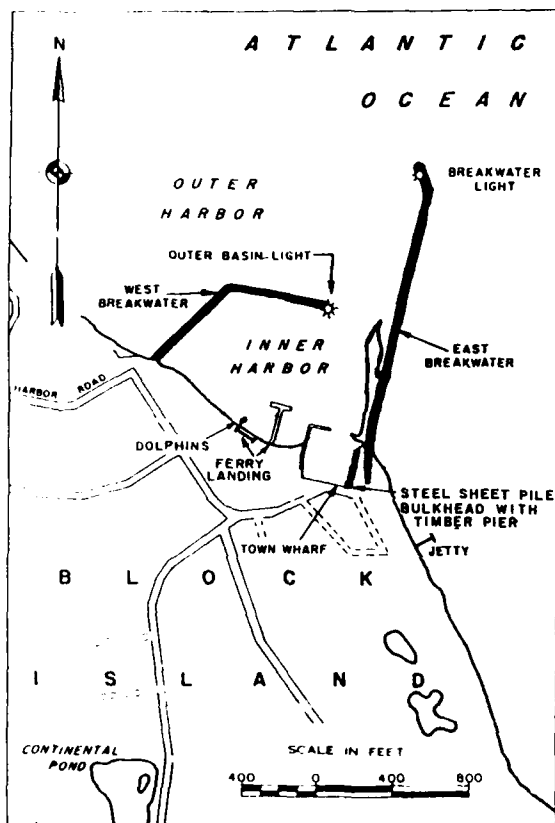
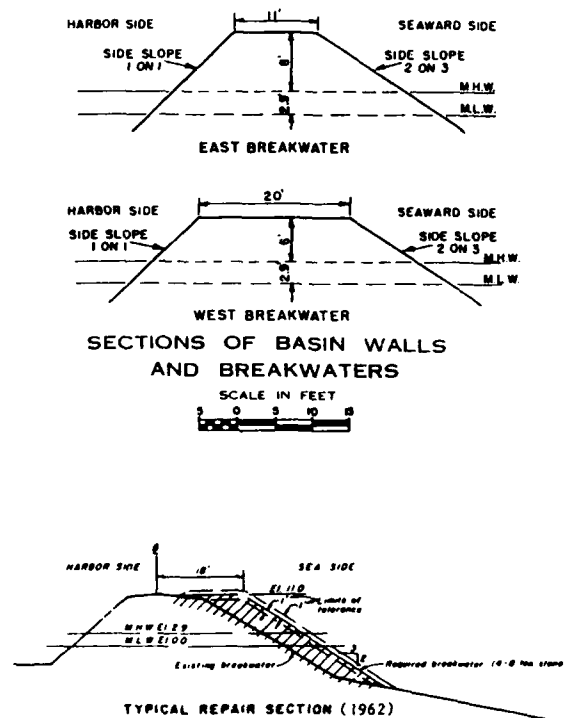
Figure 41. Plan view and typical sections of breakwaters at Block Island Harbor of Refuge, R.I.

Date(s)	Construction and Rehabilitation History
1977	Inspections up to this time indicated the west breakwater was in good condition and the east breakwater was in fair to good condition. Repair work was needed on the seaward 150 ft of the east breakwater where settlement and loss of sea-side slope stone had occurred since the 1962-63 repairs. Maintenance was subsequently performed.
1984-1987	Yearly visual inspections indicated the breakwaters were considered to be in good condition.

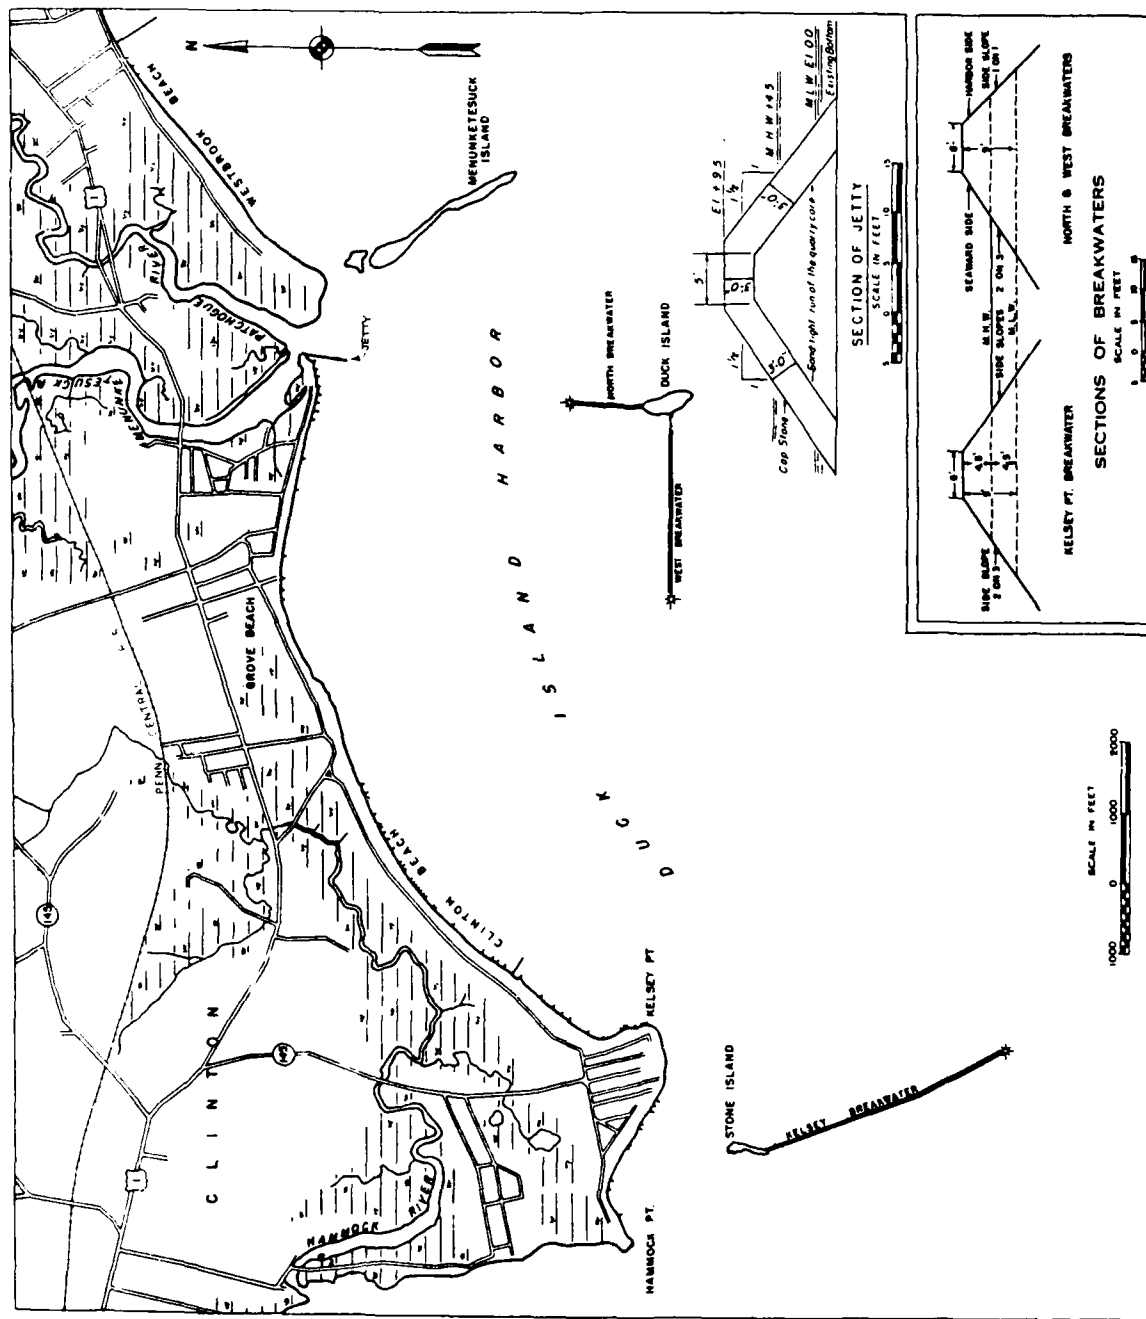
Figure 46. Location map and typical sections of Patchogue River Jetty and Duck Island Harbor breakwaters, Westbrook and Clinton, Conn.

1939	Repairs were made to the west and Kelsey breakwaters using 4,500 tons of stone for a total cost of \$25,600.
1962- 1977	Visual inspections showed the Duck Island breakwaters were in good condition while the Kelsey breakwater was rated from poor to good condition at various times. Subsequent repairs were performed.
1985	Yearly visual inspection of the structures revealed they were in good condition.
1986	Field surveys indicated the breakwaters were found to be in good condition.

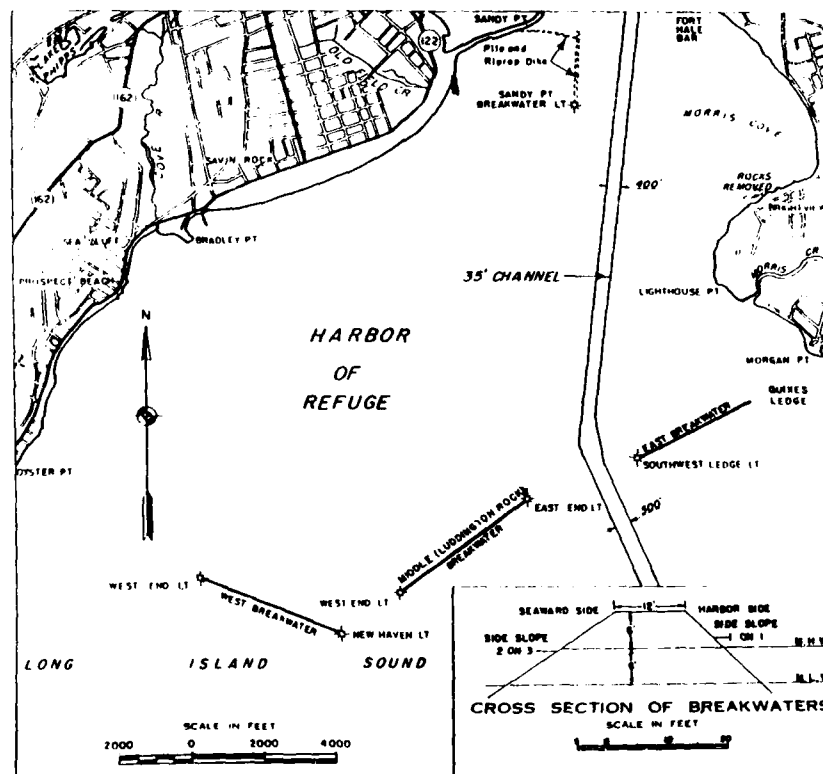
Figure 47. Breakwaters at New Haven Harbor of Refuge, Conn.

1960-1974	The breakwaters were considered to be in fair to good condition during several visual inspections taken over this period.
1984	Yearly visual inspection of breakwaters indicated they were in good condition.

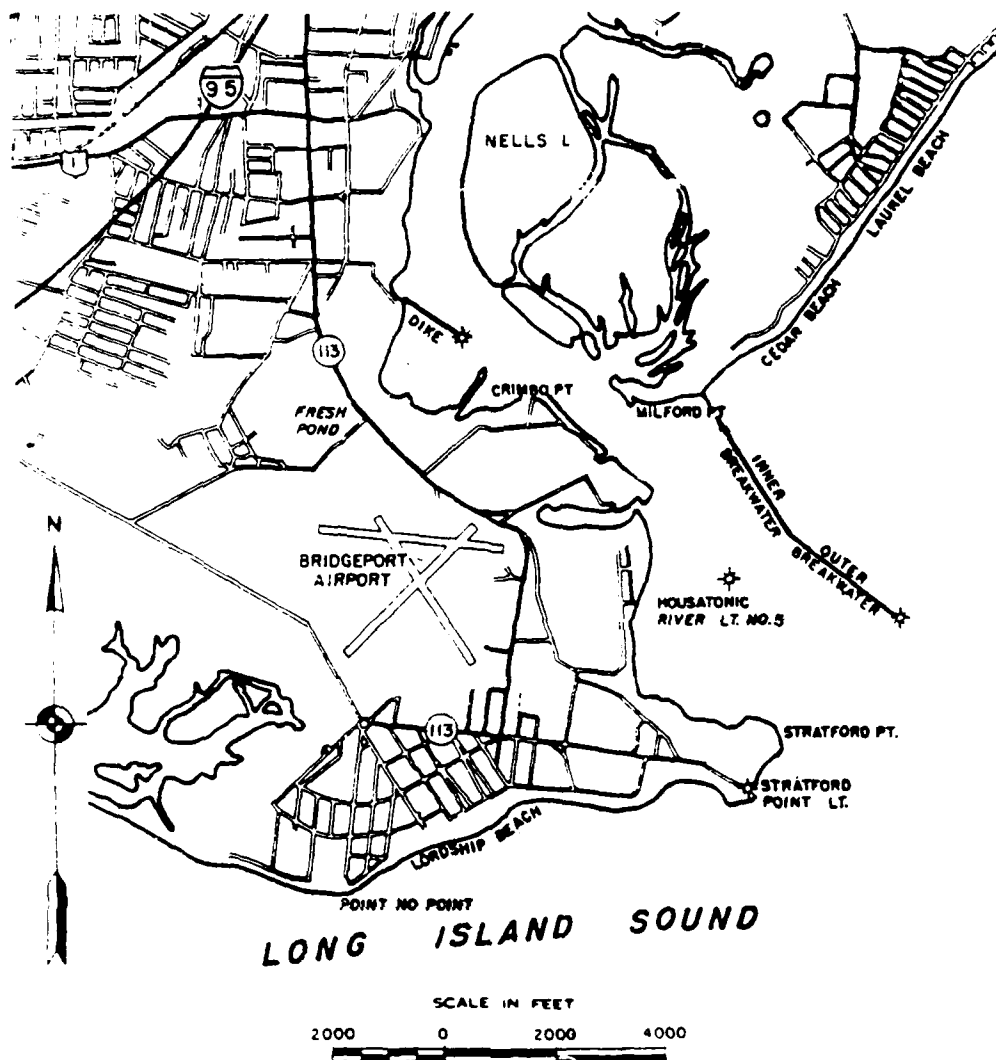
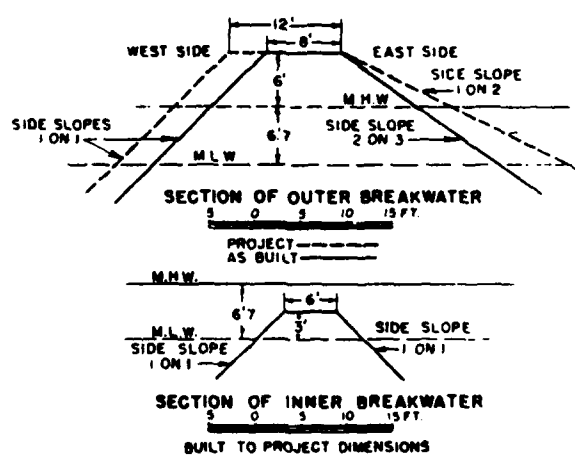
Figure 49. Plan view and cross sections of breakwater at the mouth of the Housatonic River, Conn.

1940- 1941	The outer arm was repaired using 1,350 tons of stone for a cost of \$6,700.
1960- 1977	Visual inspections showed the outer arm was in good condition, and only minor repairs were needed at the seaward end. The inner arm was in poor condition and needed repairs throughout its length.
1986	The present condition of the breakwater is not known.
